NATIONAL PHOTOGRAPHIC INTERPRETATION CENTER

Haiphong Sam Site A07-2

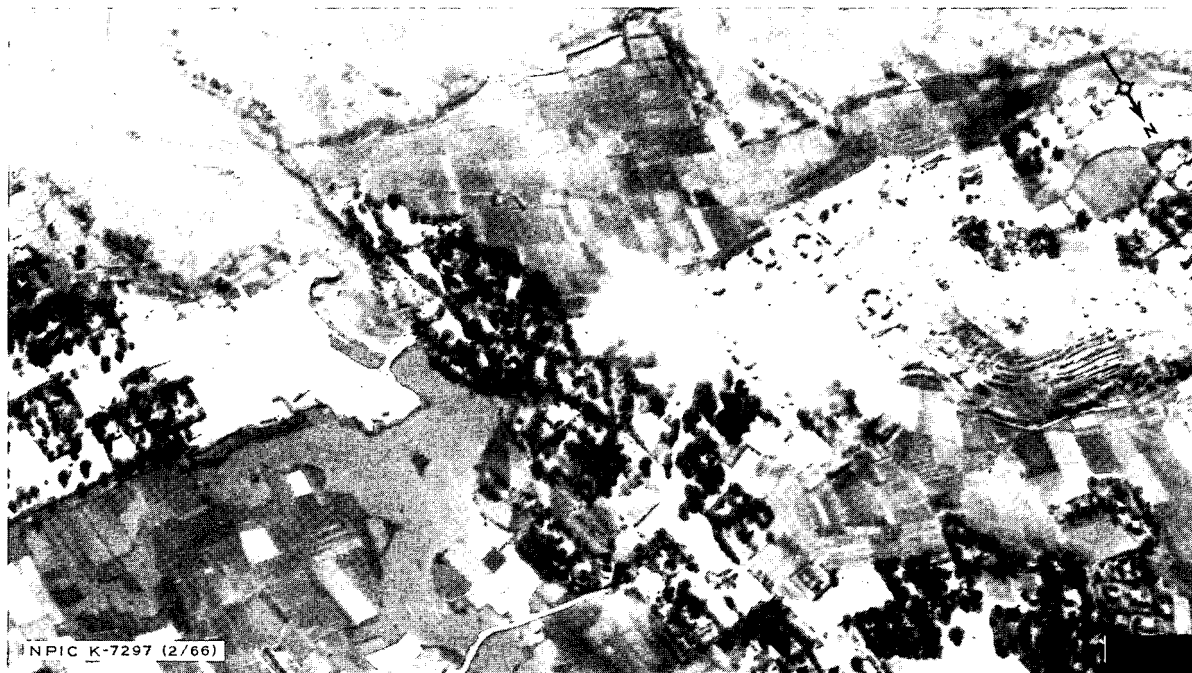
Configuration: Undetermined, lacks inner road network

Status: Under Construction

Launch Facilities: 6 positions, 4 revetted, 2 partially revetted, all unoccupied

Electronic Facilities: Central guidance area is partially revetted, unoccupied

Remarks: 7 AAA sites within 1 nm; partial coverage

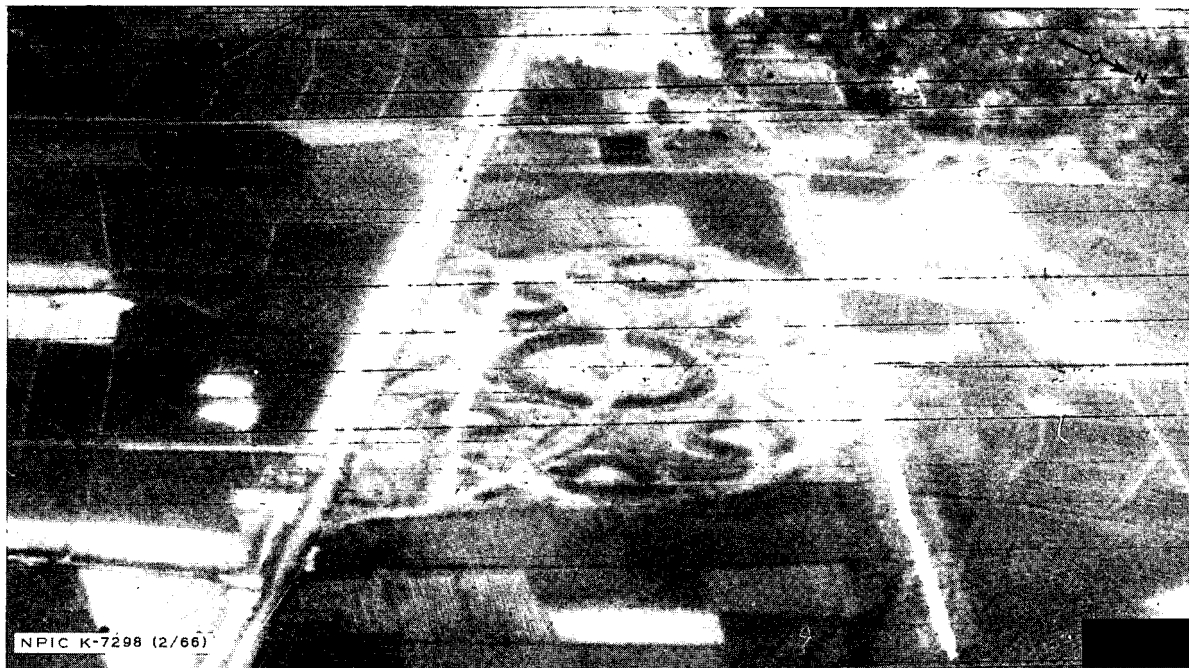
Haiphong Sam Site B28-2

Configuration: Irregular

Status: Complete

Launch Facilities: 6 positions, revetted, unoccupied

Electronic Facilities: Central guidance area is revetted, unoccupied

Remarks: 1 AAA site within 1 nm; partial coverage

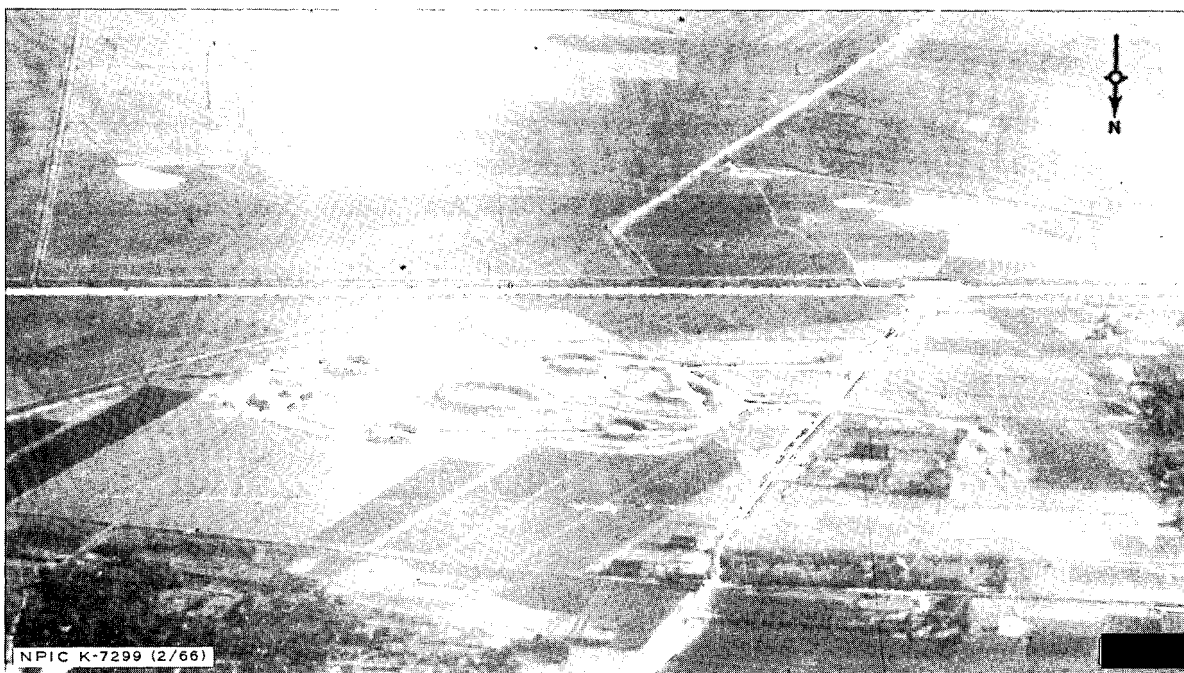
Haiphong Sam Site B30-2

Configuration: Irregular

Status: Complete

Launch Facilities: 6 positions, revetted, unoccupied

Electronic Facilities: Central guidance area is revetted, unoccupied

Remarks: 3 AAA sites within 1 nm; partial coverage

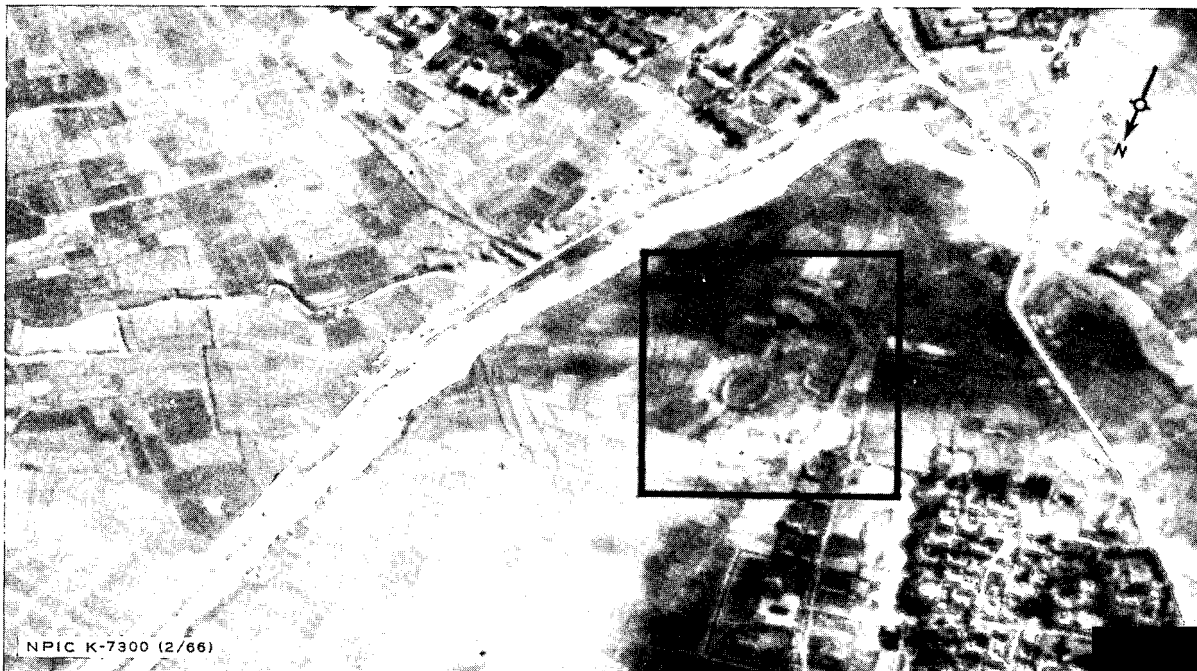
Hanoi Sam Site B33-2

Configuration: Undetermined

Status: Under construction

Launch Facilities: 4 positions, partially revetted, unoccupied

Electronic Facilities: Central guidance area is partially revetted, unoccupied

Site Support Facilities: No buildings; 2 missile-hold positions, revetted, unoccupied

Remarks: No AAA within 1 nm; scattered clouds, cloud shadow

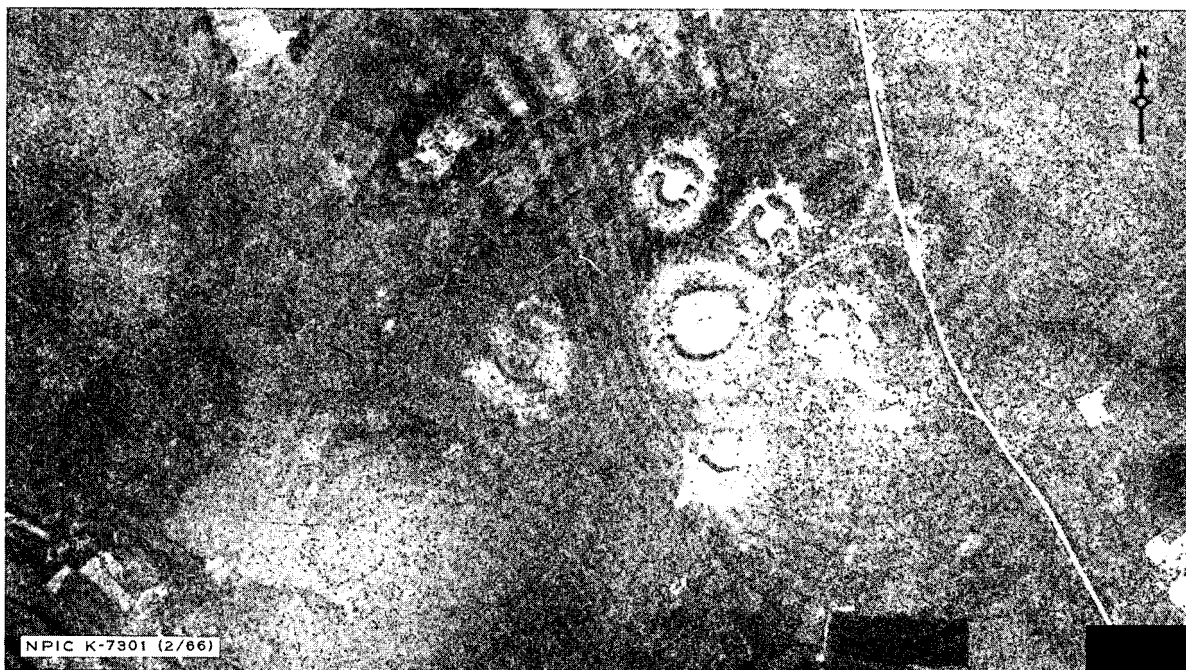
Hanoi Sam Site D36-2

Configuration: Undetermined, lacks inner road network

Status: Under construction

Launch Facilities: 5 positions, 3 revetted, 2 partially revetted, all unoccupied

Electronic Facilities: Central guidance area is revetted, unoccupied

Remarks: No AAA sites within 1 nm

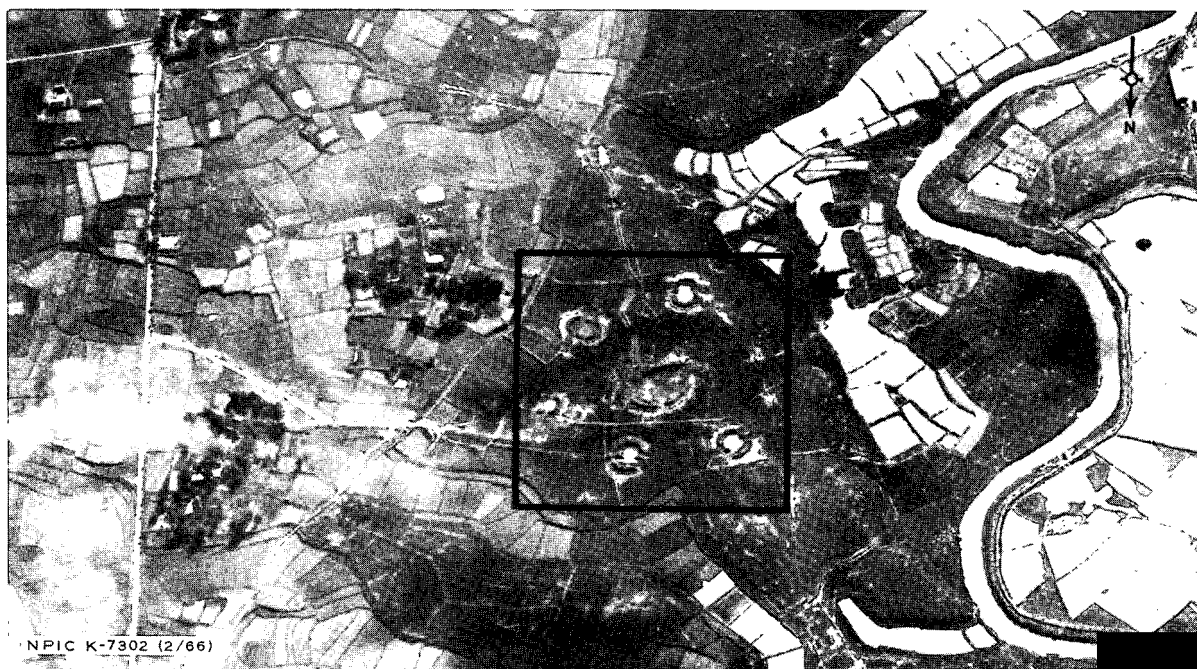
Hanoi Sam Site C04A-2

Configuration: Undetermined, lacks inner road network

Status: Under construction

Launch Facilities: 5 positions, revetted, unoccupied

Electronic Facilities: Central guidance area is partially revetted, unoccupied

Remarks: 2 AAA sites within 1 nm; scattered clouds, cloud shadow

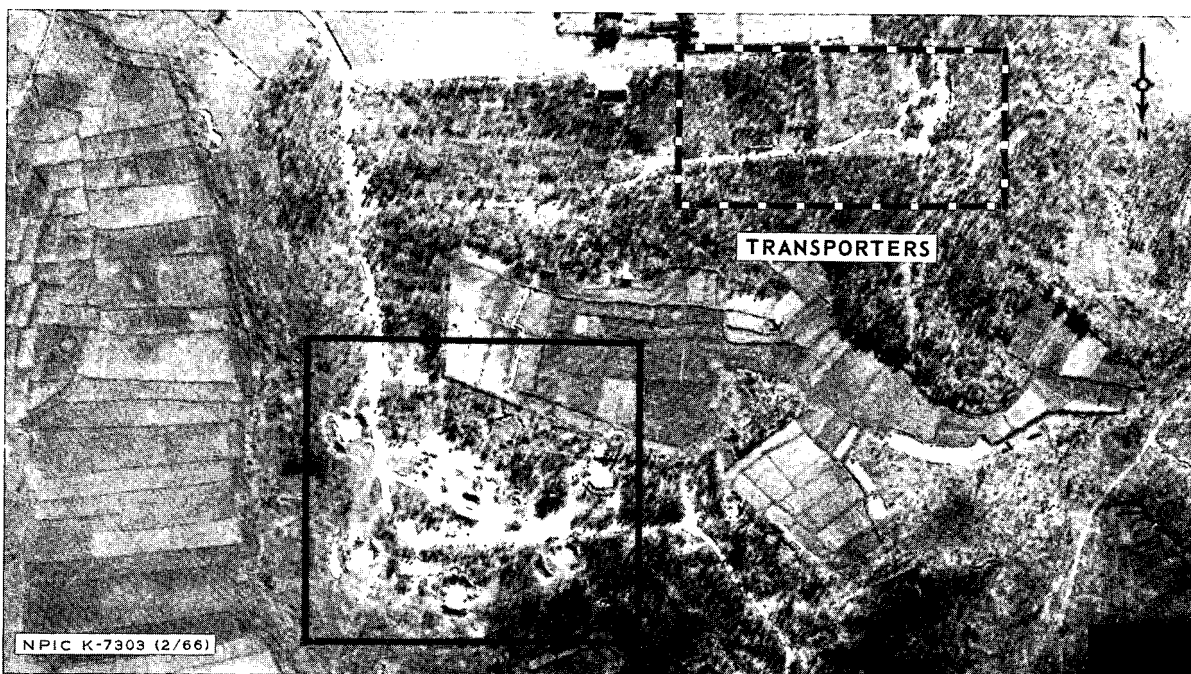
Hanoi Sam Site C02-2

Configuration: Undetermined, lacks inner road network

Status: Under construction

Launch Facilities: 5 positions, partially revetted, unoccupied

Electronic Facilities: Central guidance area is partially revetted, unoccupied

Remarks: 5 canvas-covered missile transporters and 1 possible, 700 ft SW of launch area; 5 AAA sites within 1 nm

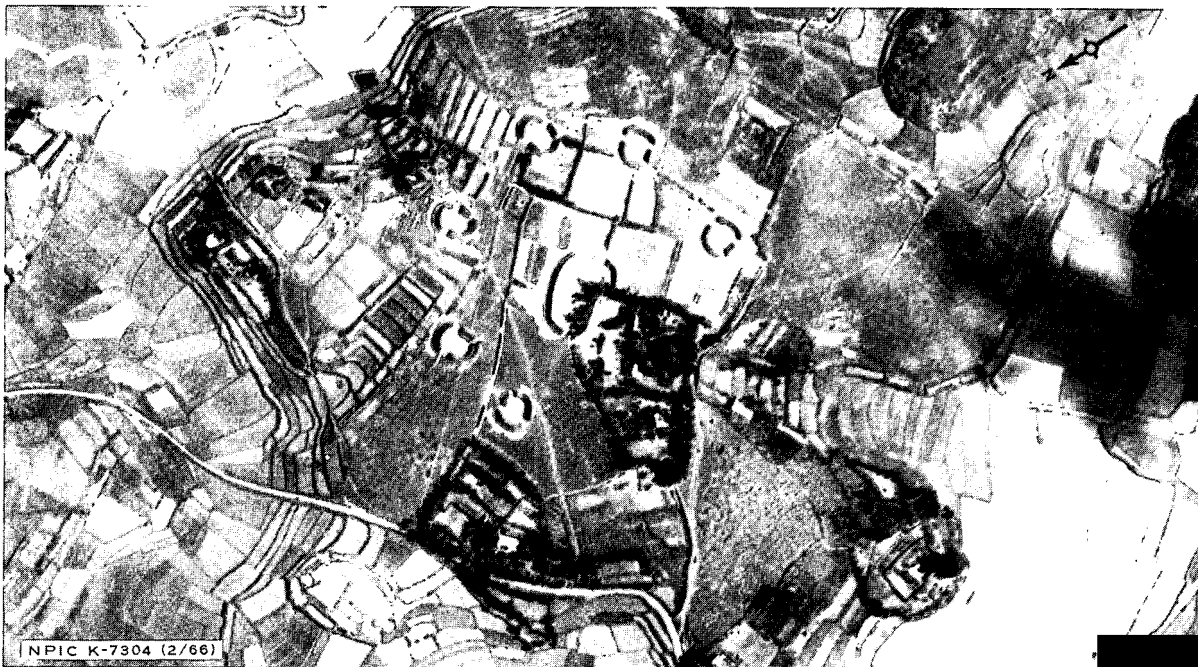
Configuration: Undetermined, lacks inner road network

Status: Complete

Launch Facilities: 6 positions, revetted, unoccupied

Electronic Facilities: Central guidance area is revetted, unoccupied

Remarks: No AAA sites within 1 nm; scattered clouds, cloud shadow

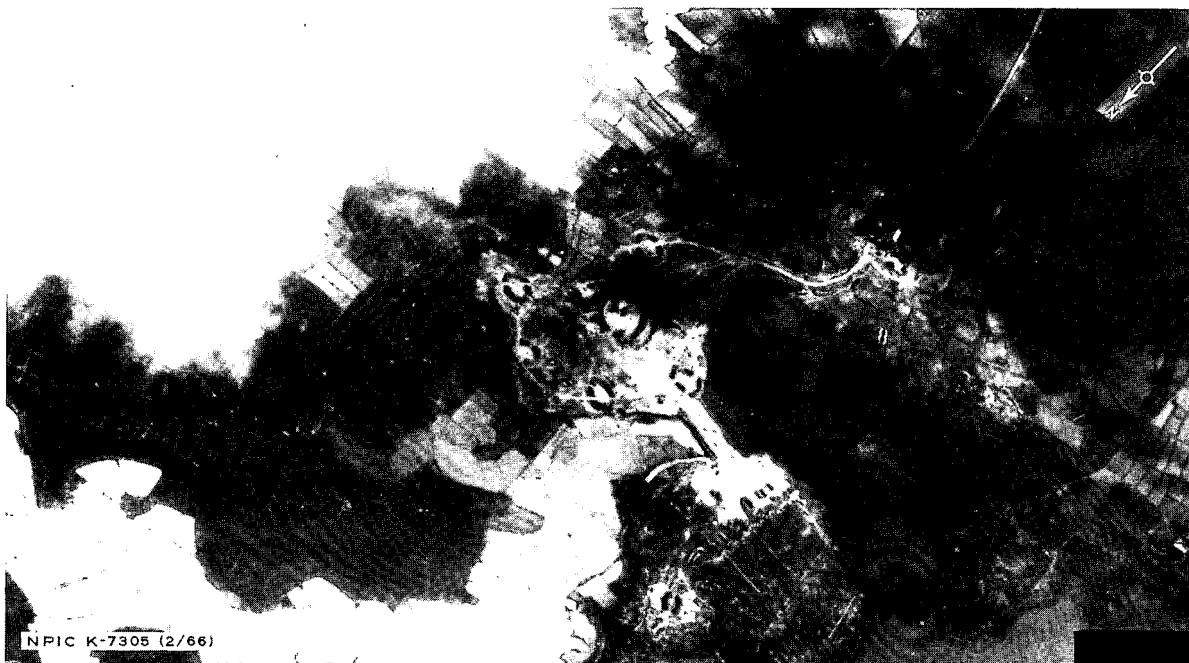
Hanoi Sam Site C05-2

Configuration: Undetermined, lacks inner road network

Status: Complete

Launch Facilities: 6 positions, revetted, unoccupied

Electronic Facilities: Central guidance area is revetted, unoccupied

Remarks: 6 AAA sites within 1 nm; scattered clouds

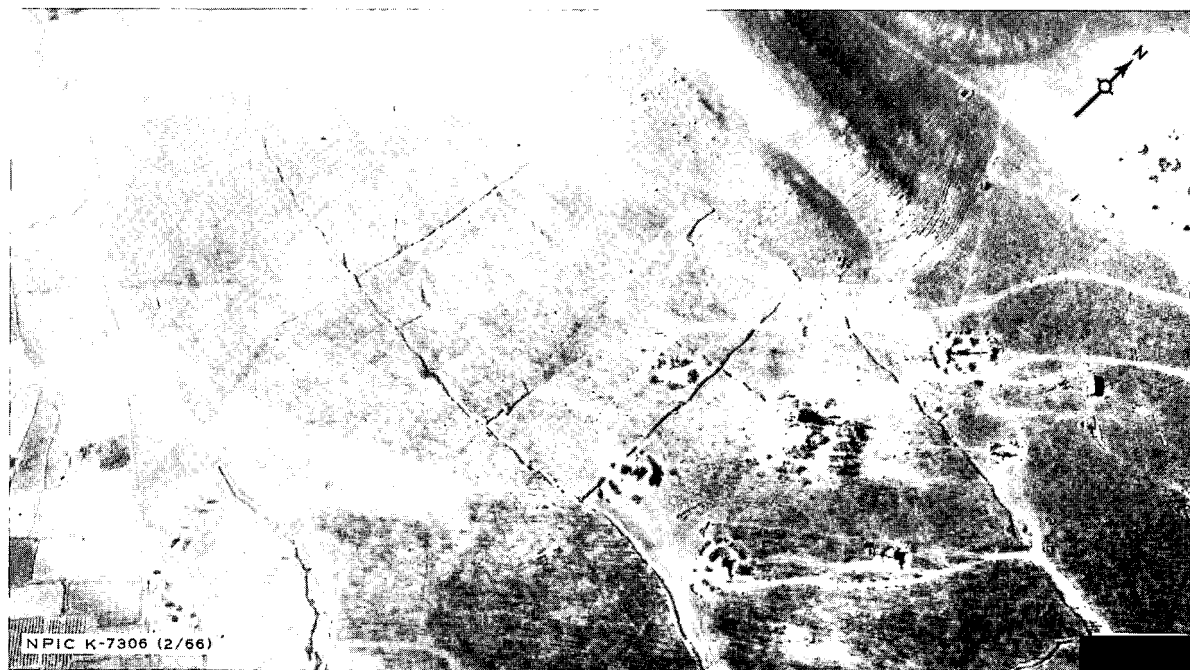
Haiphong Sam Site C32-2

Configuration: Undetermined, lacks definite inner road network

Status: Complete

Launch Facilities: 6 positions, revetted, 5 occupied by missiles on launchers, 1 unoccupied

Electronic Facilities: Central guidance area is partially revetted, occupied

Site Support Facilities: Barracks area with 17 buildings 600 ft SE of launch area; no missile-hold positions

Remarks: 3 AAA sites within 1 nm

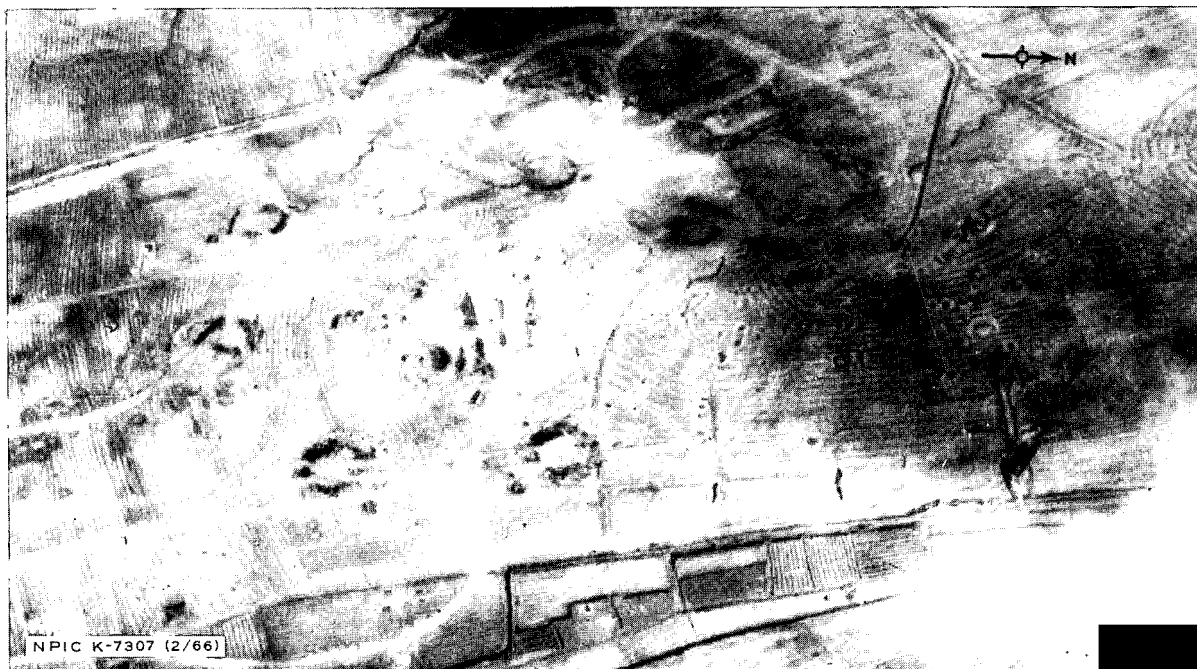
Haiphong Sam Site C32A-2

Configuration: Undetermined, lacks definite inner road network

Status: Under construction

Launch Facilities: 6 positions, partially revetted, unoccupied

Electronic Facilities: Central guidance area is partially revetted, unoccupied

Remarks: 2 AAA sites within 1 nm; scattered clouds, partial coverage
